Dealing with Disasters: An Overview of Impact and Response during the June Floods

by Sandra Lizlovs

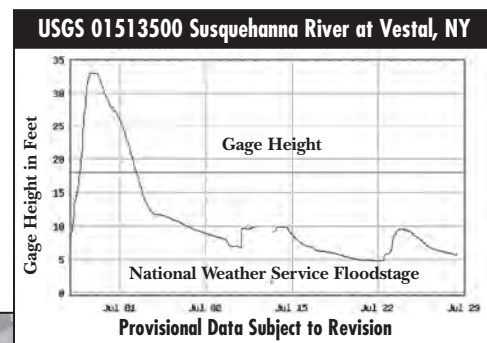
This United States Geological Survey graph shows the Susquehanna River’s peak flood stage of over 30 feet that occurred in late June.

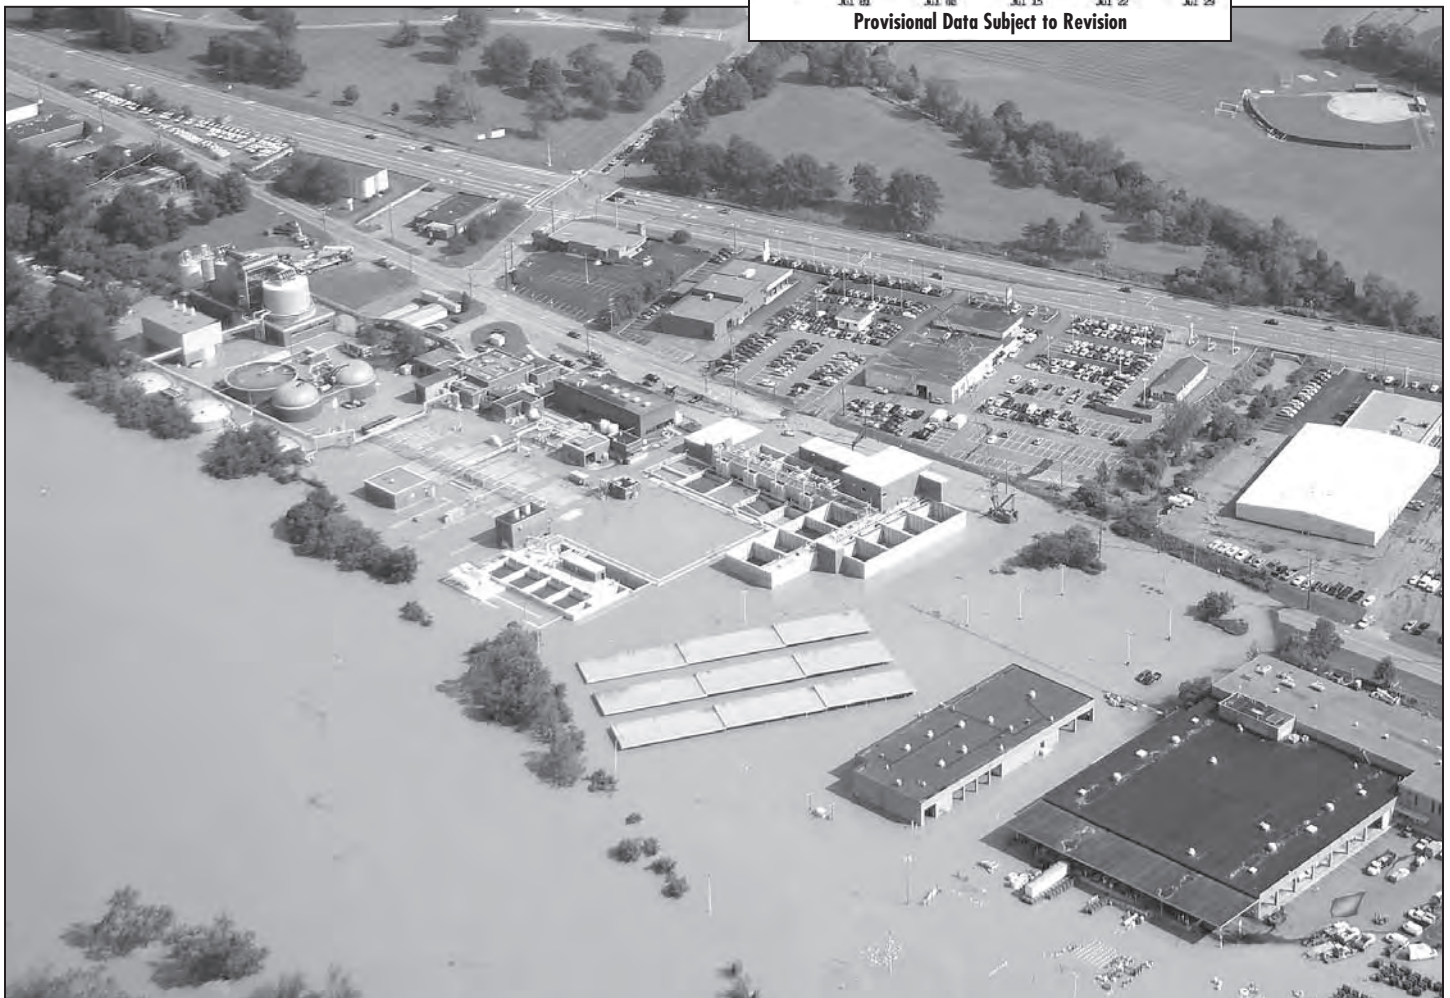
This aerial photo shows the extent of flooding around the Binghamton-Johnson City Joint Sewage Treatment Plant.

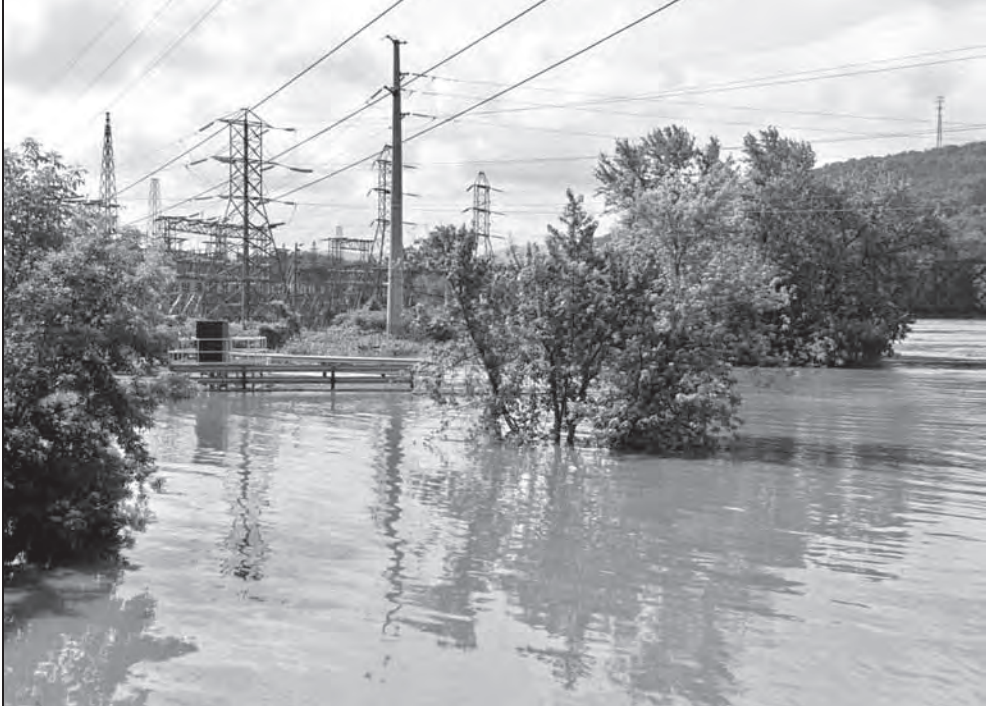
A view of control boxes for Johnson City's combined sewer overflows. In the background is the AES Power Plant in Westover, NY.

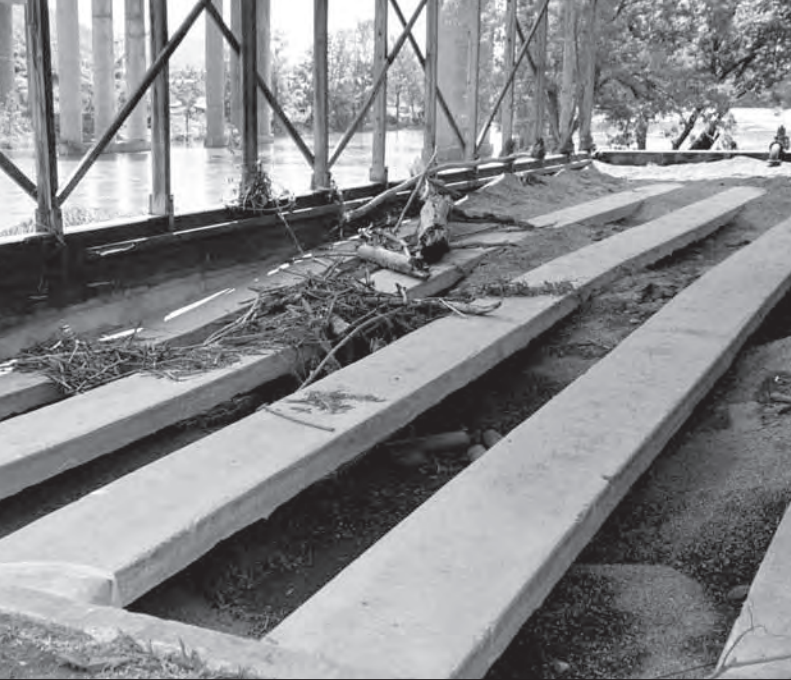
The flood destroyed the sludge drying beds at the sewage treatment plant in Deposit, NY.

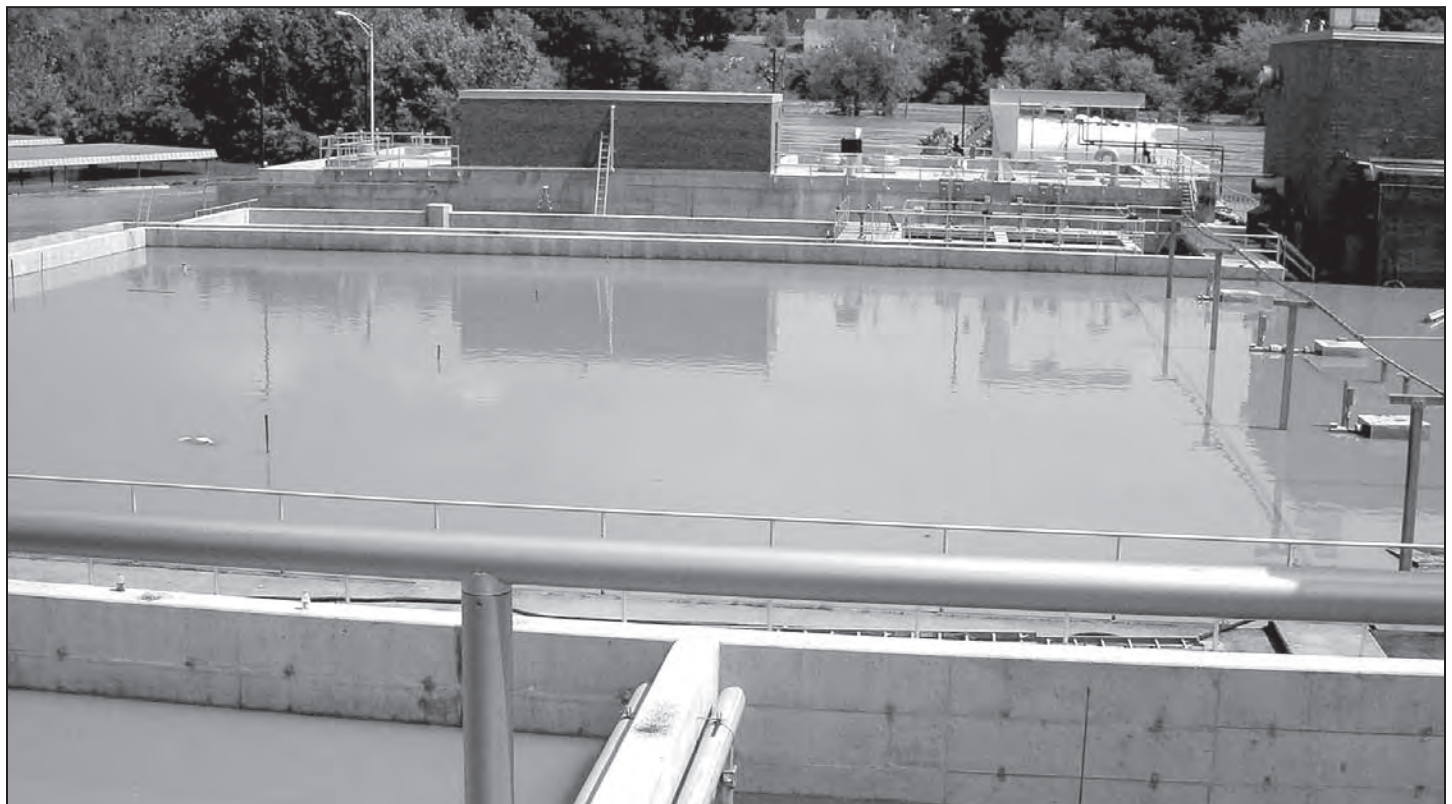
On the positive side, operators at one plant had enough spare parts on hand to replace damaged flights, motors, and drives in half of their primary clarifiers. While it took two months to get all of the primaries operational, they were able to re-establish some level of treatment within a few days.

Damaged electrical equipment was not the only problem. Mud, silt and debris removal was another common occurrence at the plants. With clarifiers submerged, anything and everything that could float down the river was trapped in the tanks. One plant removed a 55-gallon drum, a television set and a fuel oil tank from their final clarifier!

The Binghamton-Johnson City Joint Sewage Treatment Plant's primary clarifiers submerged from Susquehanna floodwaters
